DEPARTMENT OF TRANSPORTATION

Quality Assurance and Source Inspection

Contract #: 04-0120F4Cty: SF/ALA Rte: 80 PM: 13.2/13.9File #: 69.28**WELDING INSPECTION REPORT****Resident Engineer:**Pursell, Gary**Address:** 333 Burma Road**City:** Oakland, CA 94607**Report No:** WIR-010383**Date Inspected:** 26-Oct-2009**Project Name:** SAS Superstructure**OSM Arrival Time:** 700**Prime Contractor:** American Bridge/Fluor Enterprises, a JV**OSM Departure Time:** 1900**Contractor:** Zhenhua Port Machinery Company, Ltd (ZPMC), Changxing Island **Location:** Shanghai, China**CWI Name:** Sun Bo**CWI Present:** Yes No**Inspected CWI report:** Yes No N/A**Rod Oven in Use:** Yes No N/A**Electrode to specification:** Yes No N/A**Weld Procedures Followed:** Yes No N/A**Qualified Welders:** Yes No N/A**Verified Joint Fit-up:** Yes No N/A**Approved Drawings:** Yes No N/A**Approved WPS:** Yes No N/A**Delayed / Cancelled:** Yes No N/A**Bridge No:** 34-0006**Component:** OBG Crossbeams**Summary of Items Observed:**

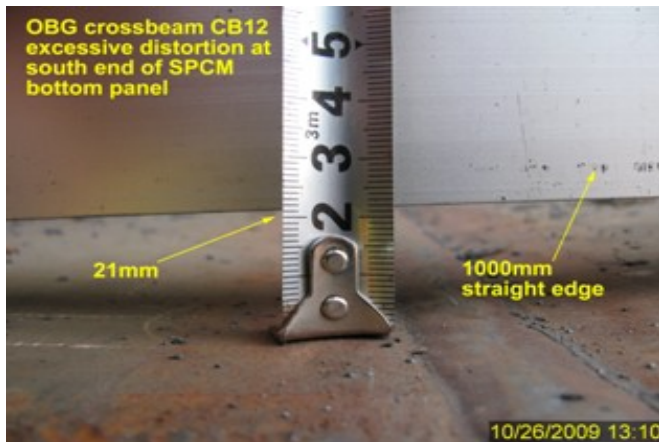
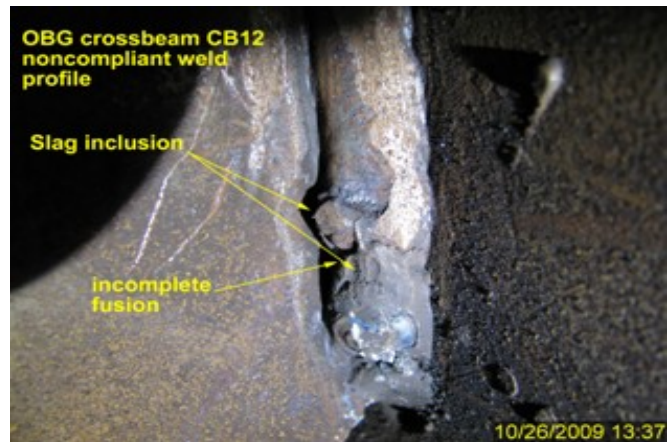
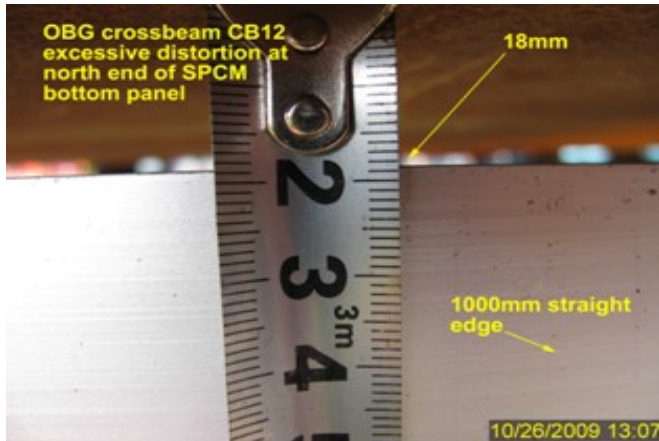
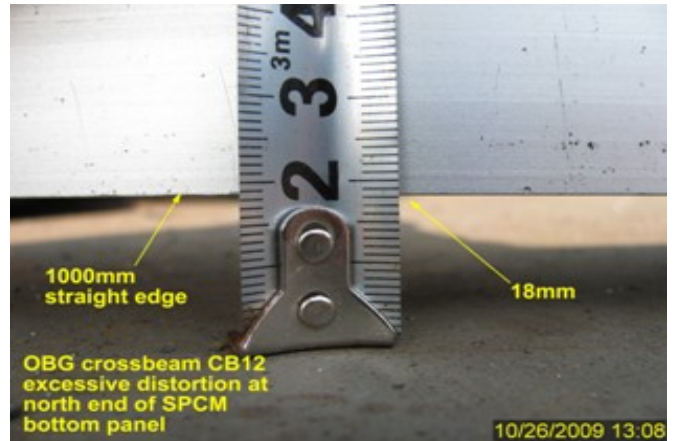
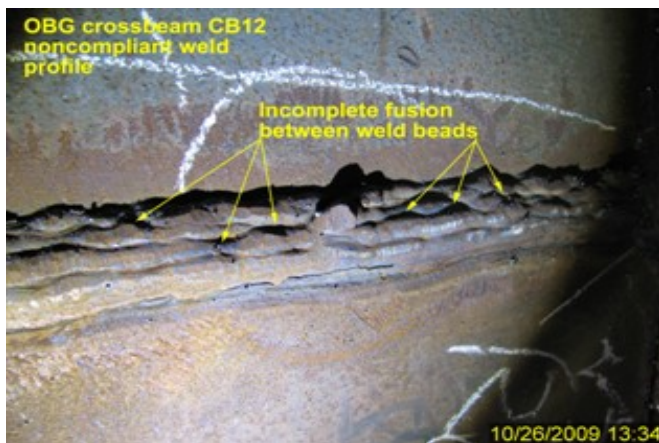
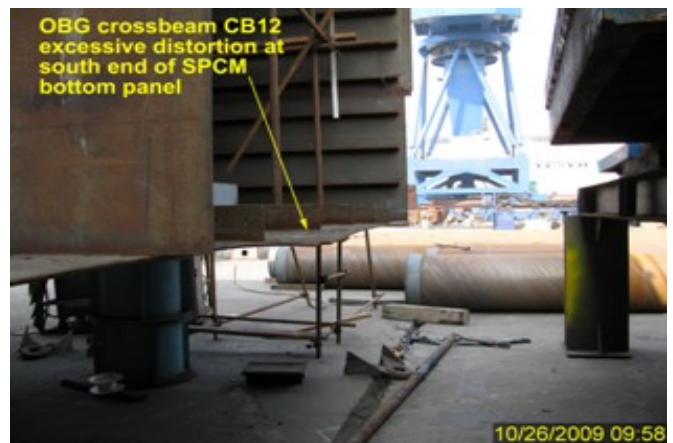
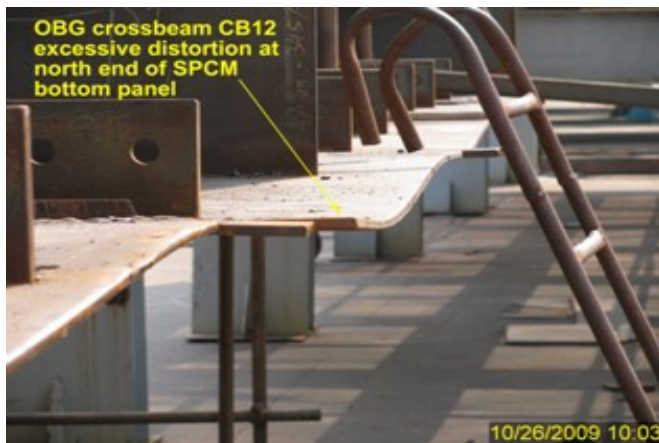
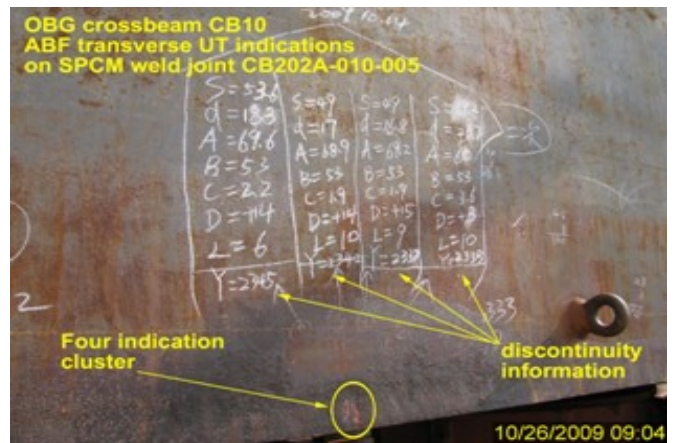
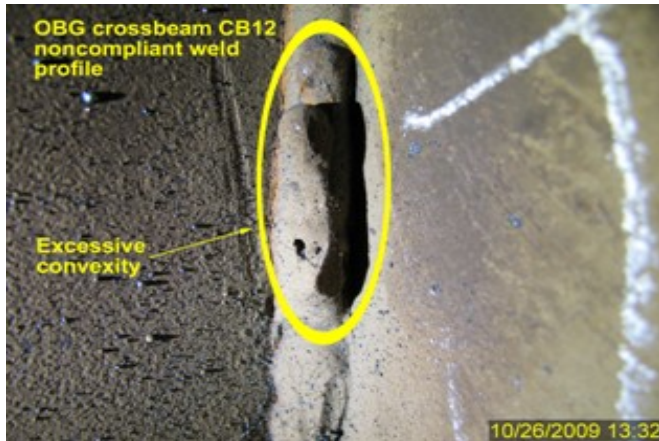
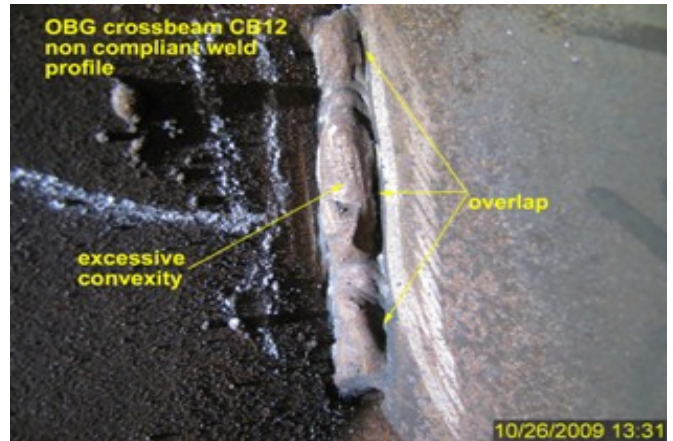
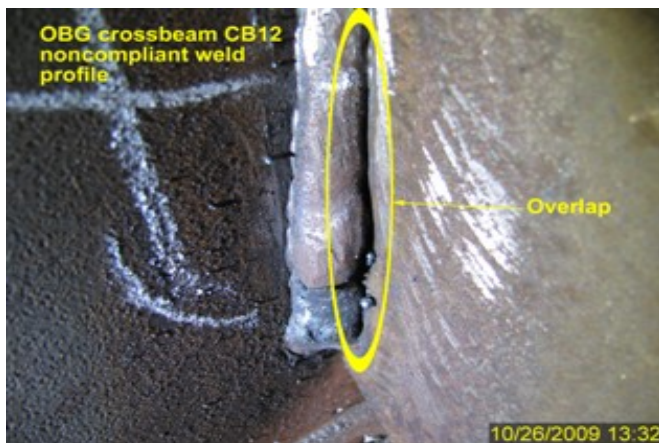
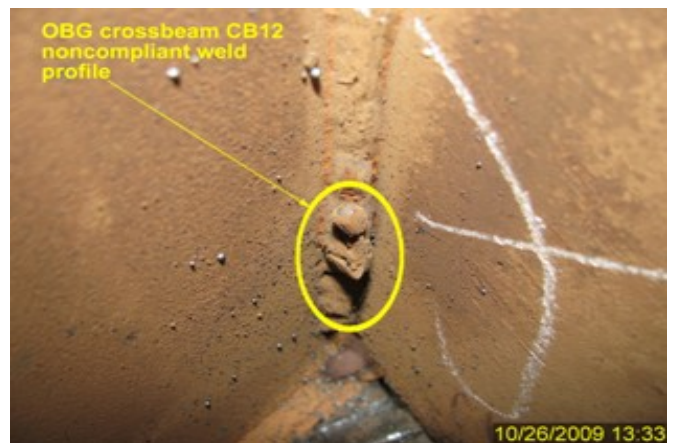
This QA observed excessive distortion on the bottom panel of this crossbeam. The bottom panel is designated on the approved shop drawings as SPCM. The distortion appears to have been created when the bottom panel was spliced and welded in subassembly. It appears as though the contractor did not attempt to straighten the material prior to incorporating the panel into the crossbeam component. Caltrans Standard specifications 55-3.02 STRAIGHTENING MATERIAL specifies “Rolled material before being laid out or worked shall be straight. Subassemblies and completed members shall be straight before being incorporated into the work”. This QA notified ZPMC QA identified as Mr. Zhang Wei and ABF inspector identified as Mr. Kelvin Cheung of this issue and informed both that an incident report would be generated. See attached photos.

During random visual inspection of the welding on this crossbeam this QA observed numerous welds that do not appear to meet the weld profile requirements specified in the contract documents. This QA noted that ZPMC and ABF have not yet performed FVT and NDT on this crossbeam. This QA photographed a number of these noncompliant welds and included them in this report for the purpose of capturing the in-process workmanship being performed on this crossbeam.
